**Flood Control Project Maintenance
Levee Inspections**

Maintenance Issue Types Only, Levee Inspection Report By Mile - Spring 2018

Reclamation District No. 1602 Del Puerto

Waterway	Bank	Unit Miles	Inspection Start/End	Inspector
Unit No. 01 San Joaquin River	Left	6.24	03/13/2018 03/13/2018	Richard Willoughby

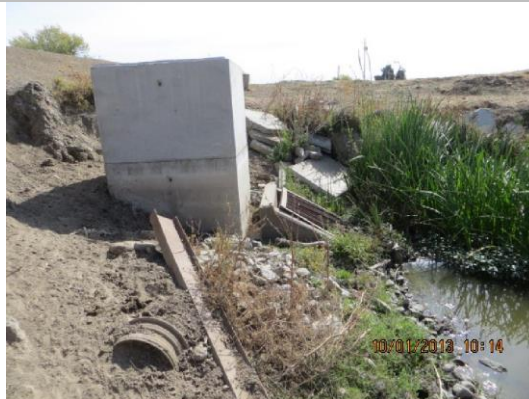
Photo 1 of 3 : UCIP_SP_2018_51329_36786.jpg

Grated inlet and 5'X5' concrete box on LS toe.

FS_ID:51329
DS_ID:20218
EP_NO: N/A
Repair Type: Urgent
Crossing Status: Found
UCIP Comments: 11/18/2016 Same as previous inspection headwall on the WS toe has separated from pipe and flap gate is still missing. Erosion around concrete headwall and undermined WS slope are visible from WS. The slope undermined appears to have progressed but no photos were taken due to the dense vegetation covering area. According to Tony Martinez, LMA representative, the WS concrete headwall has been detached since 2008/2009. LMA has been in contact with CVFPB, DWR, and USACE regarding this site. (O. Magana - DWR UCIP)10/01/2013 Headwall on WS toe separated from pipe. Erosion around concrete headwall and undermined at WS toe. Flap gate missing from WS toe headwall. (W. Wylie - DWR UCIP) FIELD_STRUCT_DESC: 30-inch square reinforced concrete box culvert through levee, 25.4 feet below crown. Concrete "U" headwalls on both waterside (WS) and landside (LS) ends. Slide gate in concrete surge box located on the WS slope. A 5-foot by 5-foot concrete box is located on LS toe. Flap gate is located on the WS end. [Additional Reference(s): DWR Levee Log, 1992. USACE San Joaquin River O&M Manual Unit 13, April 1964, (HLM 1.02), Drawing No. 7-4-1784]. FS Date: 11/18/2016

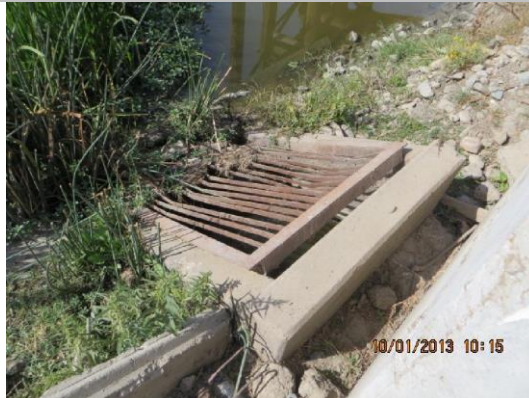
Photo 2 of 3 : UCIP_SP_2018_51329_36785.jpg

Grated inlet at LS toe.

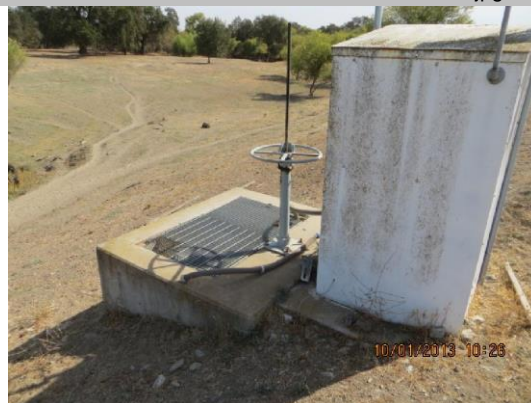
Photo 3 of 3 : UCIP_SP_2018_51329_36789.jpg

Slide gate in concrete riser next to shed on WS shoulder.

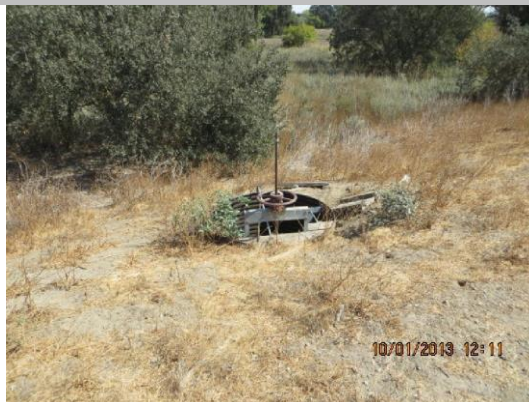
Photo 1 of 3 : UCIP_SP_2018_51336_36822.jpg

Comment Code						
Inspector Comment						
FS_ID:51336 DS_ID:20208 EP_NO: N/A Repair Type: Non-Urgent Crossing Status: Found UCIP Comments: 11/18/2016 Same as previous inspection soil and debris prevent flap gate from properly fuctioning and slide gate won't close due to sediment build up. Crossing has been downgraded from Urgent to Non-Urgent due to no pipe or levee integrity issues observed during the site visit. Need to contact owner to determine status of crossing. If crossing is no longer in use owner will need to coordinate with CVFPB to properly abandon or remove according to Title 23 requirements. (O. Magana - DWR UCIP)10/01/2013 Soil and debris prevent flapgate from proper function. Slide gate won't close completely due to sediment buildup. CMP riser needs cover. (W. Wylie - DWR UCIP) FIELD_STRUCT_DESC: 24-inch steel pipe through levee, 11.6 feet below crown. Concrete headwall on the landside (LS) end. Concrete "U" headwall and flap gate located on the waterside (WS) end. Slide gate in 60-inch corrugated metal pipe (CMP) riser is located on the WS slope. [Additional Reference(s): DWR Levee Log, 1992. USACE San Joaquin River O&M Manual Unit 13, April 1964, (HLM 5.23), Drawing No. 7-4-1784]. FS Date: 11/18/2016

Slide gate in CMP riser on WS slope. Outlet visible under tree in background.

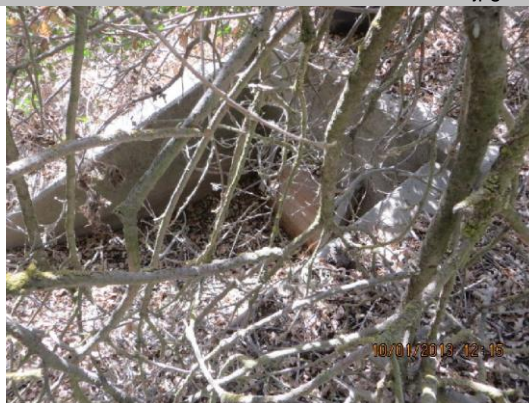
Photo 2 of 3 : UCIP_SP_2018_51336_36821.jpg

FS_ID:51336
DS_ID:20208
EP_NO: N/A
Repair Type: Non-Urgent
Crossing Status: Found
UCIP Comments: 11/18/2016 Same as previous inspection soil and debris prevent flap gate from properly functioning and slide gate won't close due to sediment build up. Crossing has been downgraded from Urgent to Non-Urgent due to no pipe or levee integrity issues observed during the site visit. Need to contact owner to determine status of crossing. If crossing is no longer in use owner will need to coordinate with CVFPB to properly abandon or remove according to Title 23 requirements. (O. Magana - DWR UCIP)10/01/2013 Soil and debris prevent flapgate from proper function. Slide gate won't close completely due to sediment buildup. CMP riser needs cover. (W. Wylie - DWR UCIP)
FIELD_STRUCT_DESC: 24-inch steel pipe through levee, 11.6 feet below crown. Concrete headwall on the landside (LS) end. Concrete "U" headwall and flap gate located on the waterside (WS) end. Slide gate in 60-inch corrugated metal pipe (CMP) riser is located on the WS slope. [Additional Reference(s): DWR Levee Log, 1992. USACE San Joaquin River O&M Manual Unit 13, April 1964, (HLM 5.23), Drawing No. 7-4-1784].

Flapgate in Concrete headwall on WS toe under tree.

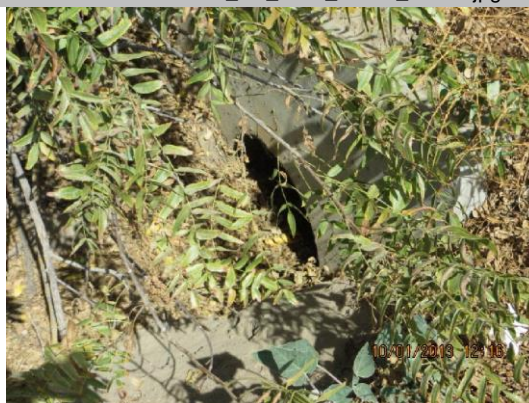
Photo 3 of 3 : UCIP_SP_2018_51336_36820.jpg

Concrete headwall at inlet on LS toe.

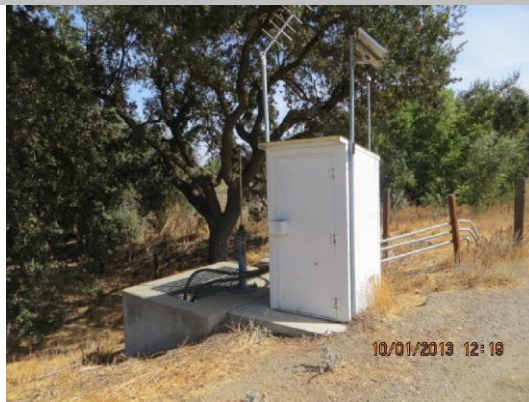
Photo 1 of 2 : UCIP_SP_2018_21665_36829.jpg

Comment Code					
Inspector Comment					
FS_ID:21665 DS_ID:20209 EP_NO: 8192 Repair Type: No Action Needed Crossing Status: Found UCIP Comments: FIELD_STRUCT_DESC: 1 of 2: 36-inch by 36-inch reinforced concrete box drainage culvert through the levee, 15.8 feet below the crown. Slide gate in a 6-foot by 7-foot concrete surge box on the waterside (WS) slope. 36-inch concrete pipes buried on both sides of the levee and connected to the reinforced concrete box culvert. Constructed through the levee section. (two 36-inch by 36-inch culvert [HLM 5.27] authorized under Automatic Board Order (ABO) issued as Permit No. 8192, 1972 - Stanislaus County). [Additional Reference(s): DWR Levee Log, 1992. USACE San Joaquin O&M Manual 13, April 1964, (HLM 5.27), Drawing No. 7-4-1784]. FS Date: 10/1/2013

Shed with slide gate in Concrete riser on WS shoulder.

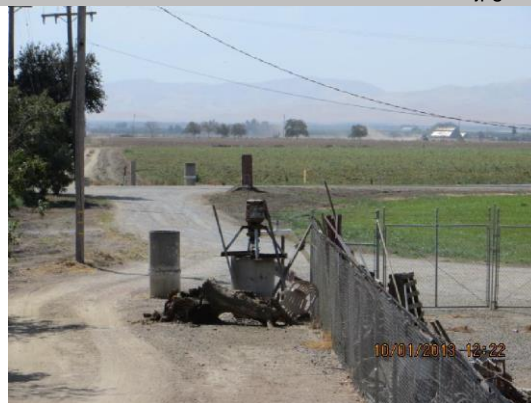
Photo 2 of 2 : UCIP_SP_2018_21665_36828.jpg

Likely risers for pipe off LS toe.

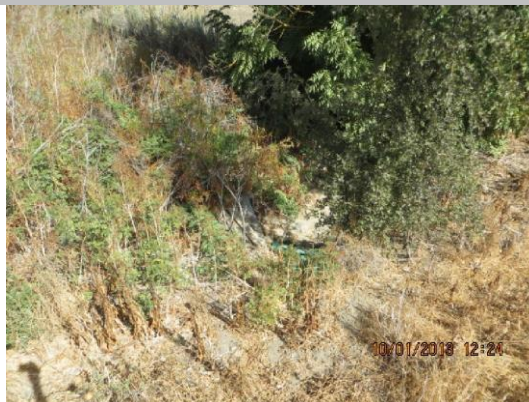
Photo 2 of 3 : UCIP_SP_2018_21672_36847.jpg

Concrete outlet on WS toe.

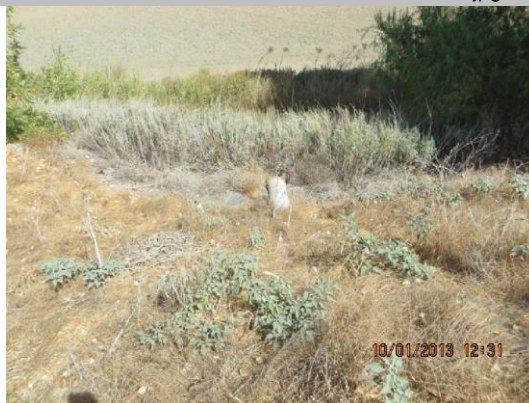
Photo 1 of 1 : UCIP_SP_2018_21674_36854.jpg

LM Start	5.46	Rating **	M	Issue No.	213
LM End	5.46	Issue Type +	Ma	Location *	
Category	Supplemental			GPS Latitude/Longitude	
				Start	End
Item	DWR UCIP LMA Responsibility			37.433646 °	37.433646 °
				-121.033846 °	-121.033846 °
DWR ID					
Comment Code					
Inspector Comment					
FS_ID:21674 DS_ID:20211 EP_NO: N/A Repair Type: Non-Urgent Crossing Status: Found UCIP Comments: Pipe appears abandoned and if so should be done so properly. FIELD_STRUCT_DESC: *ABANDONED* 12-inch drainage pipe of an unknown material through the levee, 6.9 feet below the crown. Flap gate on the waterside (WS) end. Could not locate, March 1984. (Reclamation District No. 1602). [Additional Reference(s): DWR Levee Log, 1992. USACE San Joaquin O&M Manual 13, April 1964, (HLM 5.50), Drawing No. 7-4-1784]. FS Date: 10/1/2013

Pipe and flapgate visible on WS toe.

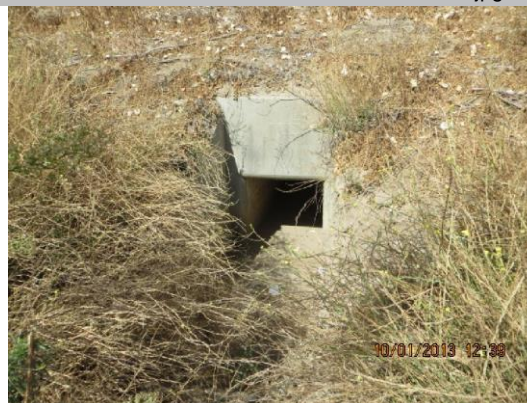
Photo 3 of 3 : UCIP_SP_2018_51337_36876.jpg

Comment Code						
Inspector Comment						
FS_ID:51337 DS_ID:20212 EP_NO: N/A Repair Type: Non-Urgent Crossing Status: Found UCIP Comments: 11/18/2016 Crossing has been downgraded from Urgent to Non-Urgent flap gate is functional. Recommend clearing dense vegetation from WS and LS slopes. (O. Magana - DWR UCIP)10/01/2013 Flapgate has minor blockage preventing gate from fully closing. (W. Wylie - DWR UCIP) FIELD_STRUCT_DESC: 30-inch square reinforced concrete box culvert through levee, 9 feet below crown. Slide gate in concrete surge box is located on the waterside (WS) slope. Concrete "U" headwalls are located on both the waterside (WS) and landside (LS) ends. Flap gate is located on the WS end. [Additional Reference(s): DWR Levee Log, 1992. USACE San Joaquin River O&M Manual Unit 13, April 1964, (HLM 5.28), Drawing No. 7-4-1784]. FS Date: 11/18/2016

Concrete U-shaped headwall on LS toe.
